Manhole Inspection Summary

Manhole # S33M__030MH

Insp Date: **3/7/08 1:23 PM**

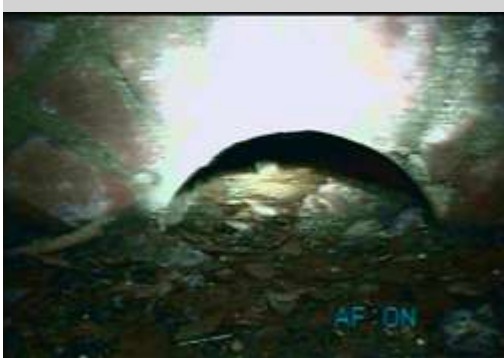
Defect 3

Condition: ☐ Sound ☐ Cracked ☐ Root Intrusion ☐ Deteriorated ☐ Leaks ☒ **Debris**

channel cond debris

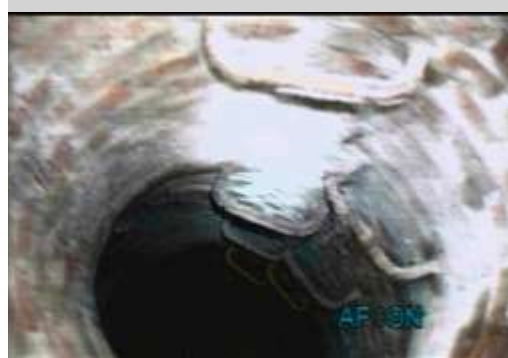
Defect 1

Count: **7** Missing: **0** ☒ **Corroded**

steps

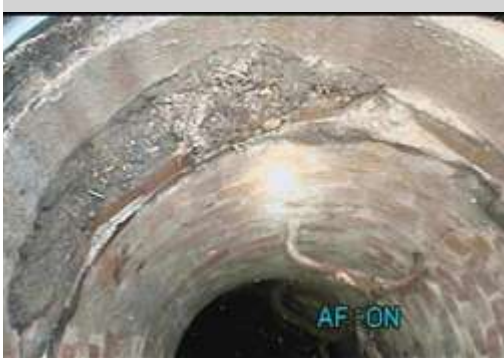
Defect 2

Offset: **3** (in.)

off set frame

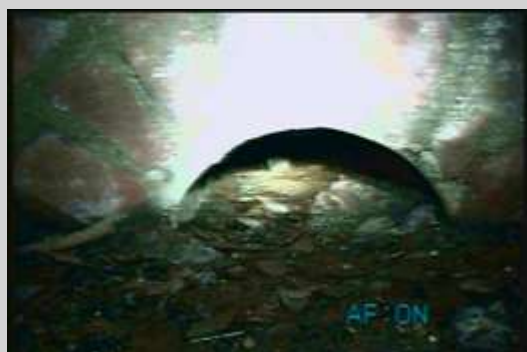
12 O'Clock Outflow

Deposits: ☐ None ☐ Mud ☐ Sludge ☒ **Debris** ☐ Grease

Silt Depth: **6** (in.) Deposits Extent: **Heavy**
